# KEYS ENGINEERING SERVICES

April 8, 2019

Re: Engineering Evaluation of City Hall Building  
As a Result of Hurricane Irma

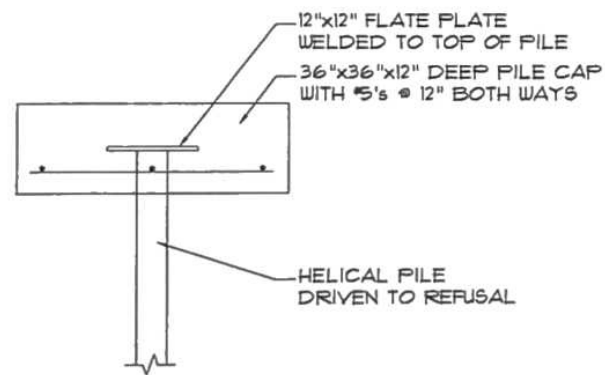
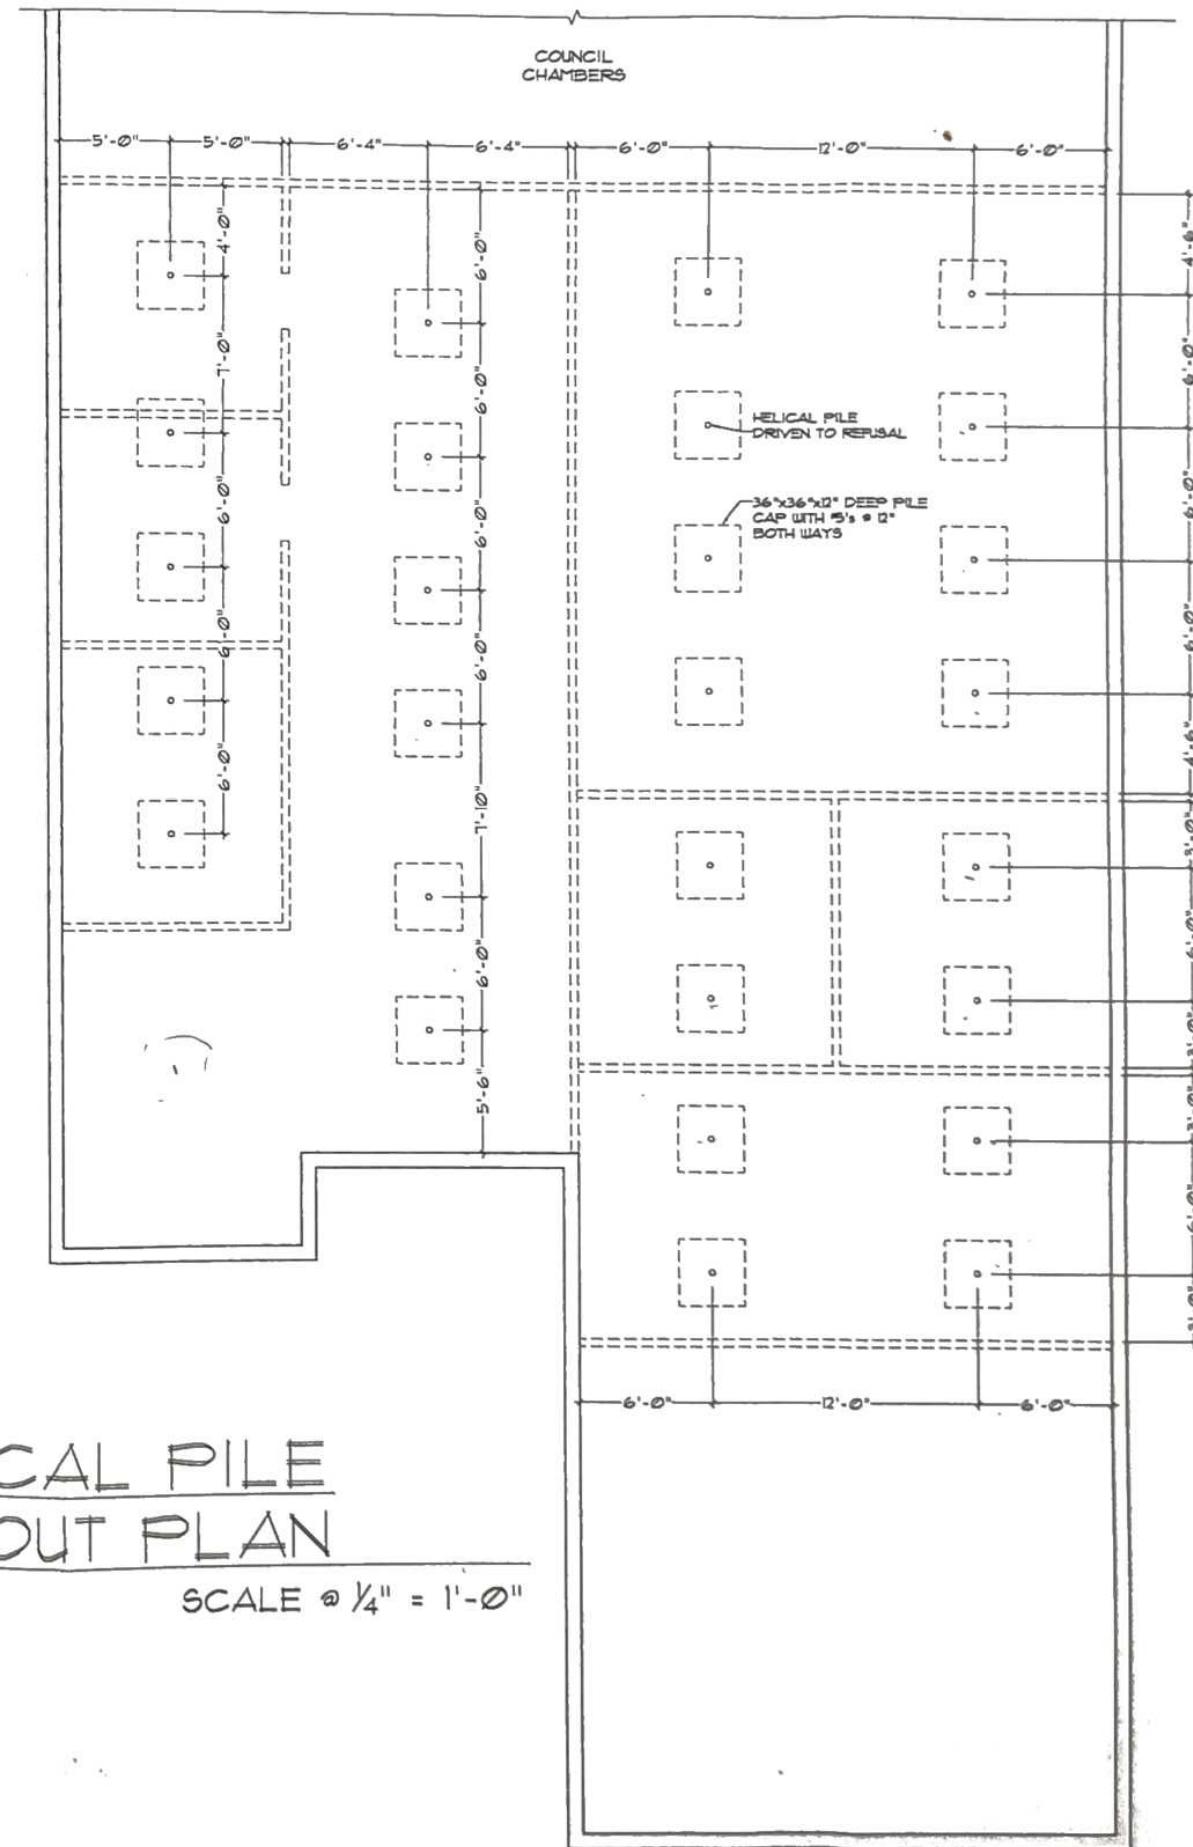
**HELICAL PILE  
LAYOUT PLAN**  
SCALE @ 1/4" = 1'-0"

The concrete slab on-grade floors in this area has a noticeable deflection in the floors. This is due to underlying soils decomposing and creating voids beneath the not structurally designed floor system. Refer to attached drawings for recommended repairs.
